CAN-AM*

Service Bulletin

Subject **CHOKE ASSEMBLY**
 Models **3841 and 3851 (TNT 125 and 175cc)**
 Serial nos. **From All to incl.**
 Date **July 19, 1973**

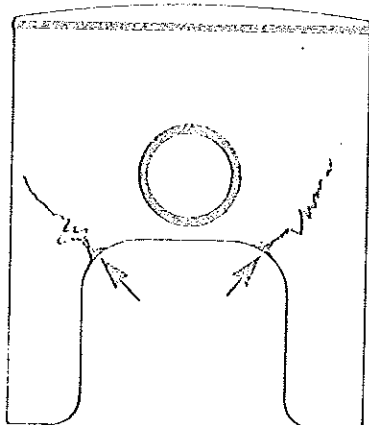
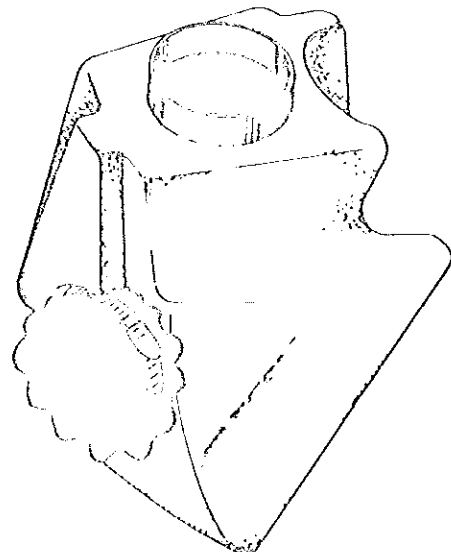
Piston breakage generally occurs when piston/cylinder clearance is excessive due to piston wear. Rapid piston wear is the direct result of dust entering the engine through the intake system.

It is of prime importance that the air filter be properly serviced as often as possible according to the procedures described in the Owner's Manual.

Every time the filter is serviced, the air box should be checked for leaks. To do so, remove the air box/carburetor rubber adaptor, block the carburetor/air box opening with a piece of old tube and a collar. Fill the box with water. Any leak should be repaired with fiberglass resin or with silicone rubber. When this operation is completed, make

If dust is suspected to have entered the engine, check for excessive clearance between piston and cylinder.

Piston/cylinder clearance limits:

125cc :	Min. 0.0025"	Max. 0.006"
175cc :	Min. 0.0025"	Max. 0.006"

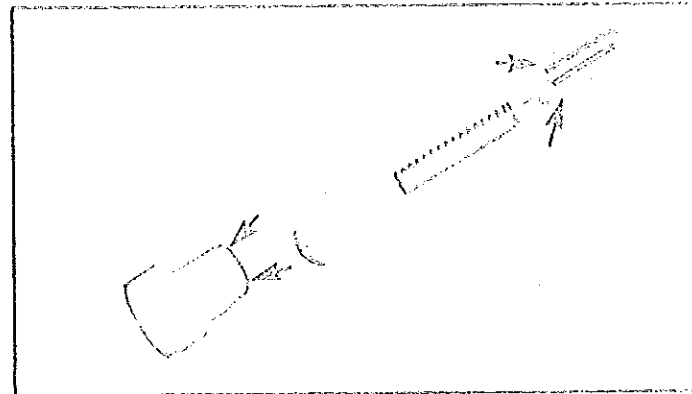
If the shifting mechanism is excessively hard to operate, the problem can generally be traced to a faulty shift drum index plunger assembly.

File the sharp machined edges of the plunger and the plunger body (as indicated on picture). If the problem persists, the index plunger assembly should be replaced.
