BOMBARDIER*

Service Bulletin

no. 16

Subject CRANKSHAFT REBUILD KIT

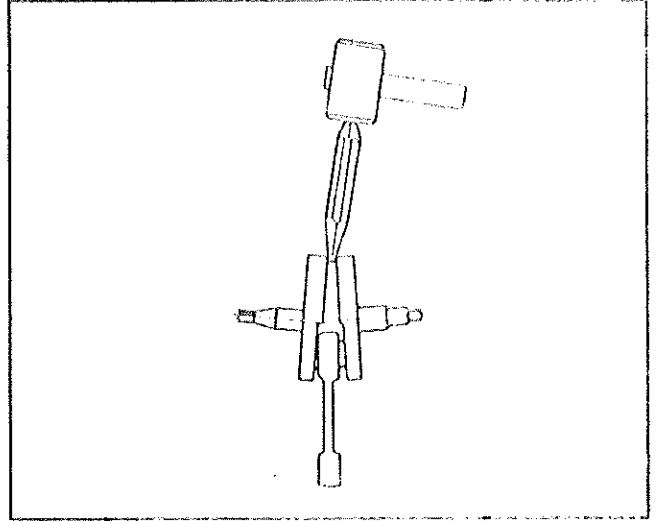
8. Using a micrometer or vernier caliper, check for flywheel alignment.

Use a wedge to correct this situation.

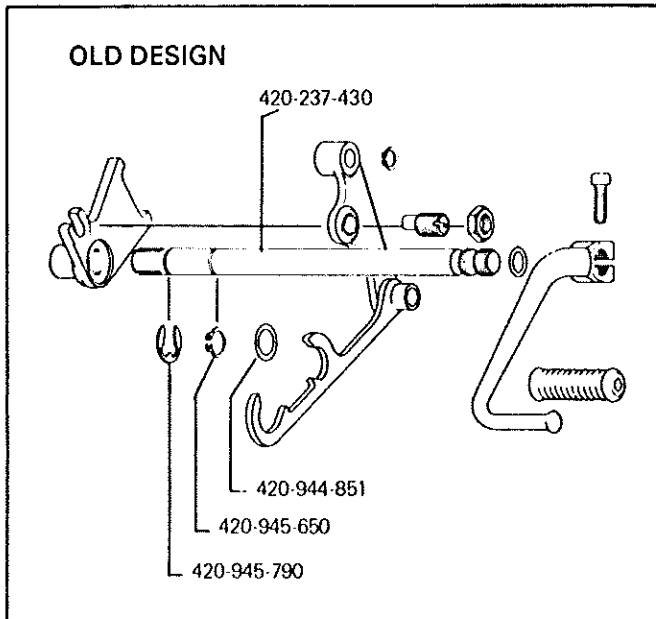
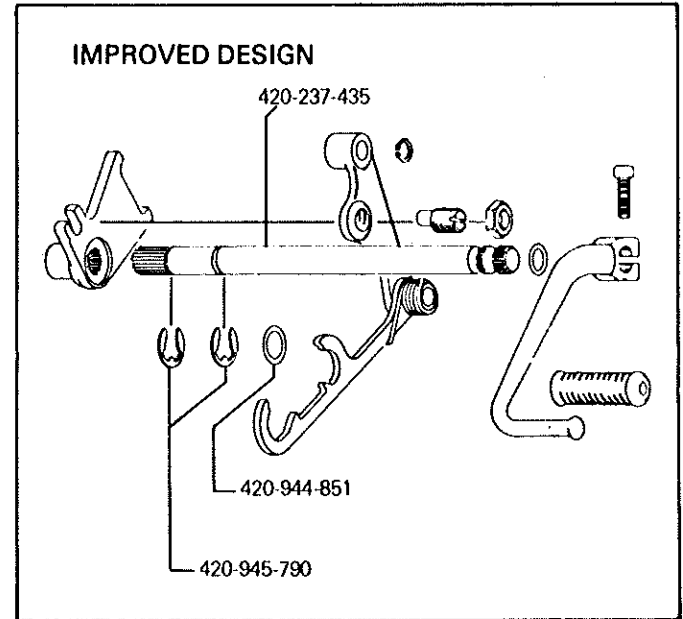
Snapping, p / n 420-945-650, has been known to come out of the locating groove in shift shaft, p / n 420-237-430, allowing the shift shaft to slide outwards and away from the actuator lever spline.

Unfortunately, this requires complete engine disassembly to correct the situation.

The remedy for this problem is to install shift shaft, p / n 420-237-435, with the larger clip, p / n 420-945-790.

○ NOTE: Be sure to include thrust washer, p / n 420-944-851.

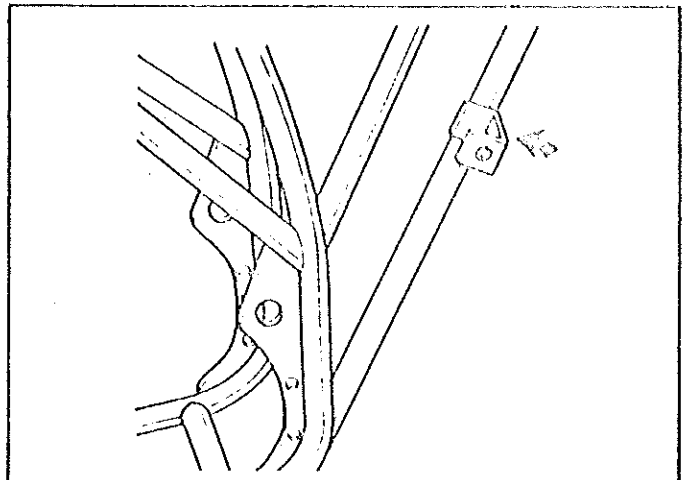
In the case of breakage of the left side panel bracket, a replacement is now available under part number 746 063-001.

This bracket can be gas or heli-arc welded, but care should be exercised not to overheat the air box area close to the frame. A heat shield should be employed between airbox and frame tube to prevent airbox from melting during welding.

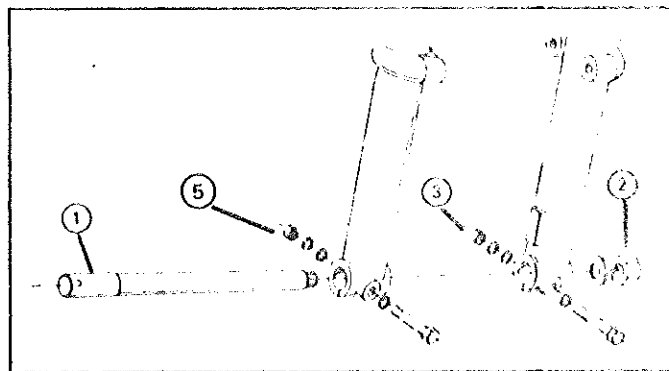
It has been reported that the fork sliders stick or jam after motorcycle assembly or front wheel servicing. The most probable cause of this situation is misaligned fork legs.

- ① Position wheel then insert axle from magneto side.
- ② Tighten axle nut.
- ③ Tighten the clutch side axle pinch bolt.
4. Depress the fork two or three times to align fork.
- ⑤ Tighten the magneto side axle pinch bolt.

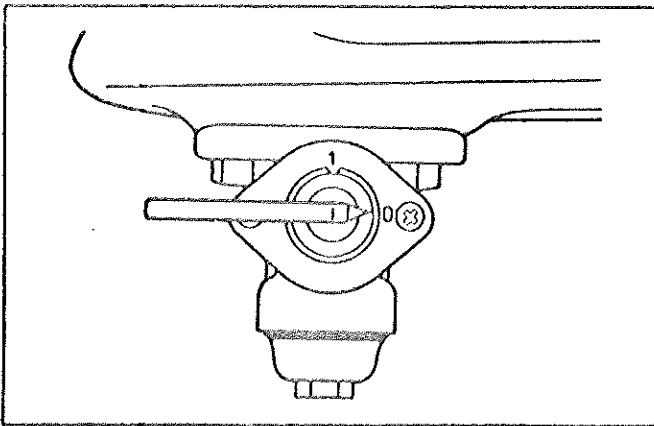
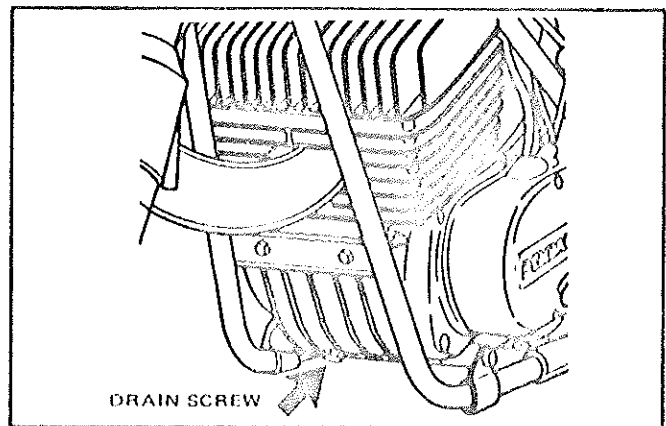
The carburetor float needle is designed to regulate fuel flow to the float chamber. It cannot act as a shut-off valve.

Gasoline in crankcase may cause connecting rod or connecting rod bearing damage when engine is cranked, due to hydraulic piston lock.

Anytime a Can-Am motorcycle is not in use, the fuel shut-off valve should be closed (#0 position) to prevent gasoline overflowing into the intake manifold and engine crankcase.

If gasoline is suspected to be present in crankcase, remove the crankcase drain screw and allow the crankcase to drain before starting.

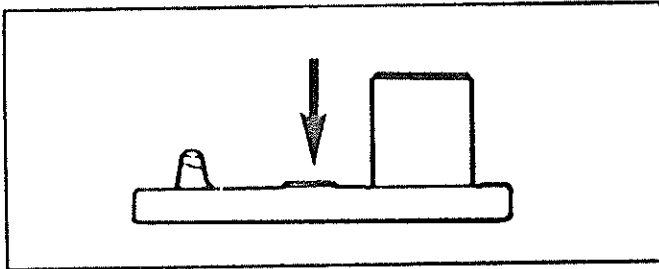
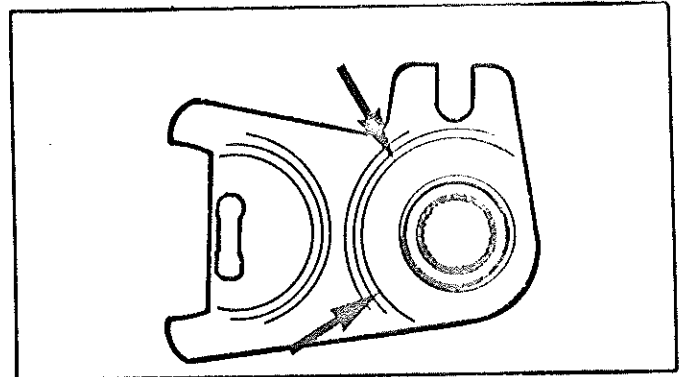
PROBLEM: When fitting a new transmission lever, p/n 420 258 575, you may find that the shifter shaft has no end play, and that the shifter level will not return to its static position properly.

PROBABLE CAUSE: The new actuating lever has a slight ridge on the outer thrust washer support face (see drawing) that has eliminated the necessary clearance.

NOTE: Even the slightest ridge may cause a problem.

SOLUTION: Using a grinder (eg: Dremel), remove the ridge until the thrust washer sits flatly in position.

NOTE: Check for shift shaft end play when crankcase is firmly bolted together.

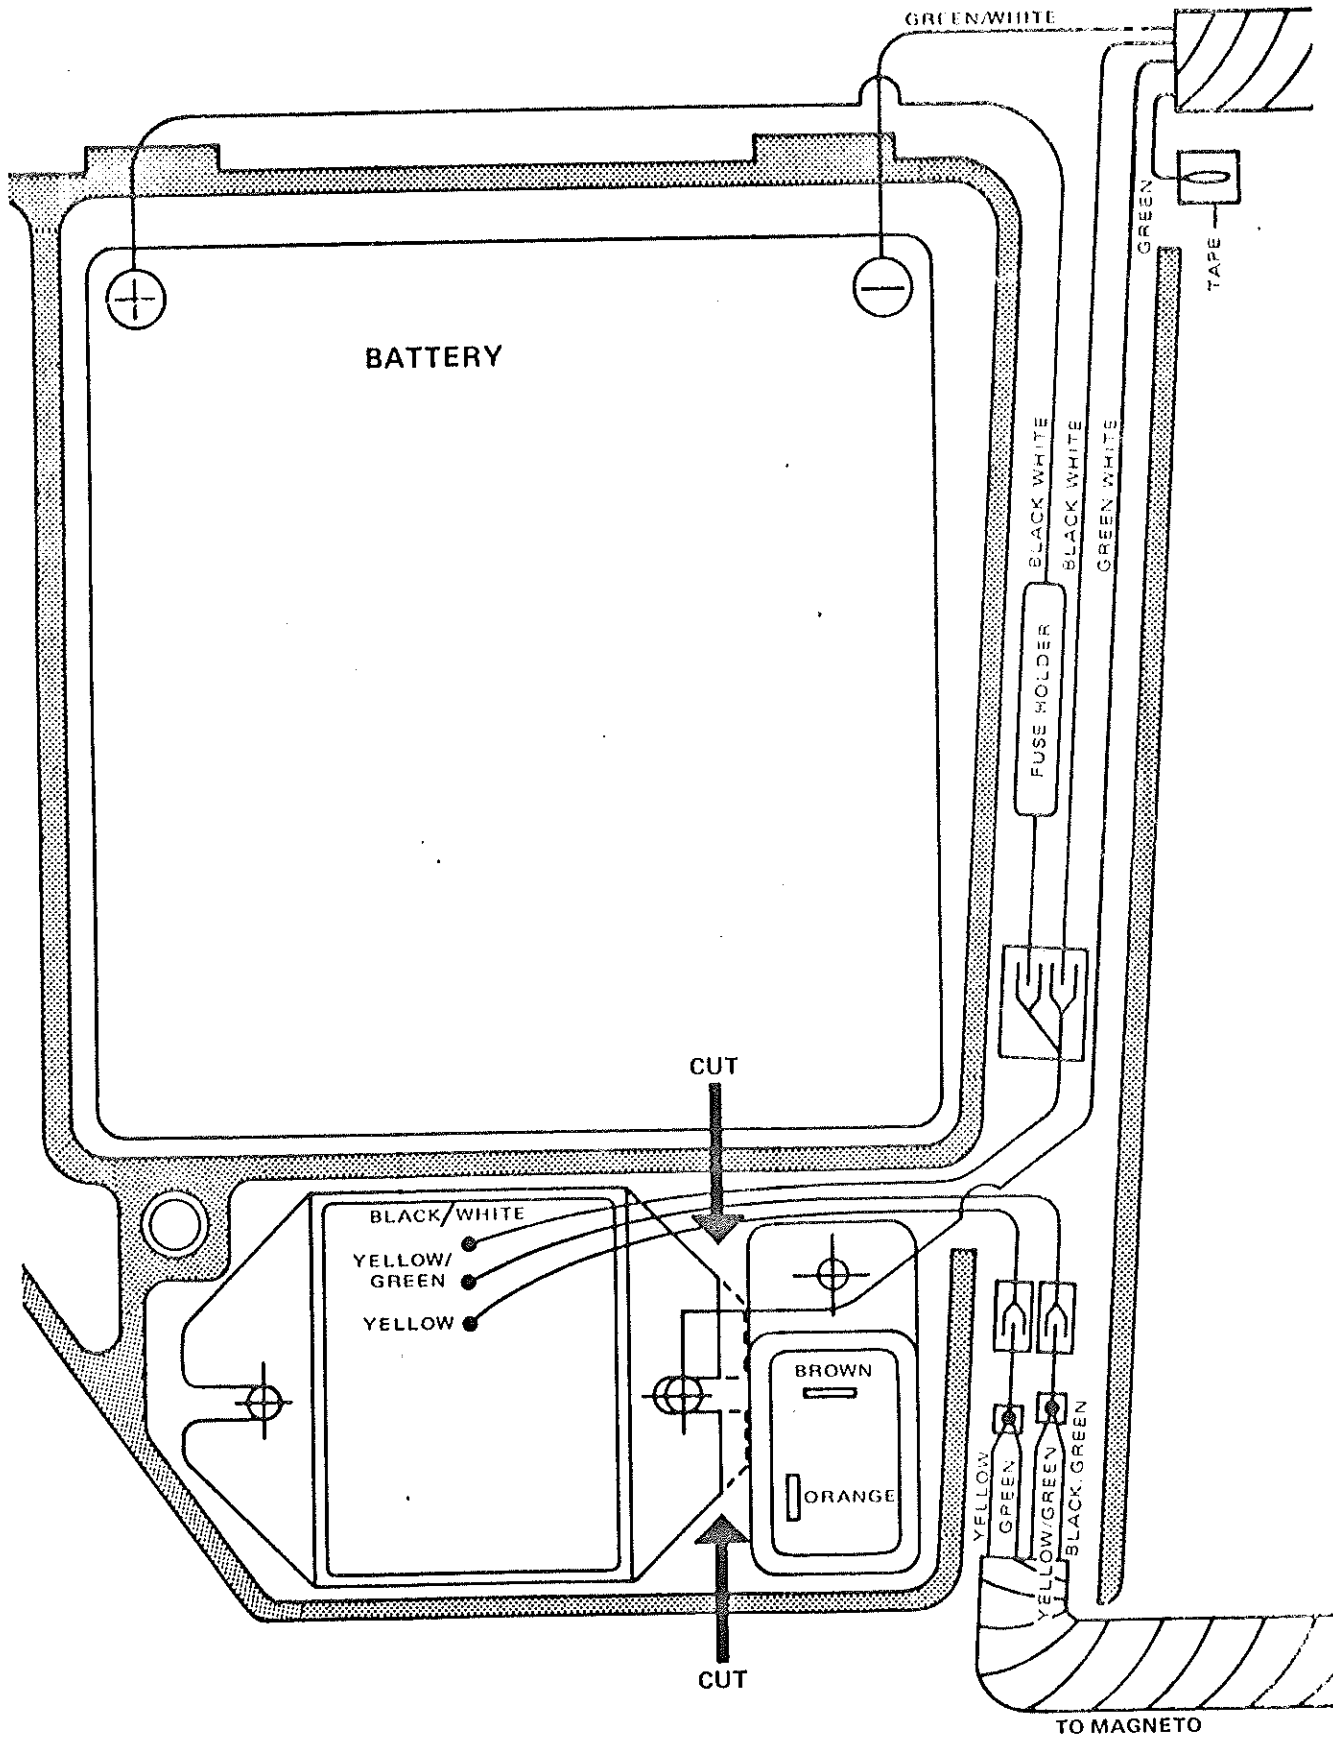
The "Bosch" rectifier, p/n 738-038-000, has been replaced by a new rectifier, p/n 738-038-003. Due to a difference in the internal circuit, some minor wiring changes must be made (as shown) if a new rectifier is to be fitted.

5. Fit the new rectifier and the rubber box into place (as shown), mark and drill the holes required, and bolt them into place.

NOTE: Cut the rectifier flange as shown.

7. As per the drawing, route all wires eliminating as much surplus length as possible.

8. Using crimp connectors or "twist, solder and tape" joints, connect the wires as shown.
