BOMBARDIER*

Service Bulletin

no. 16

Subject CRANKSHAFT REBUILD KIT

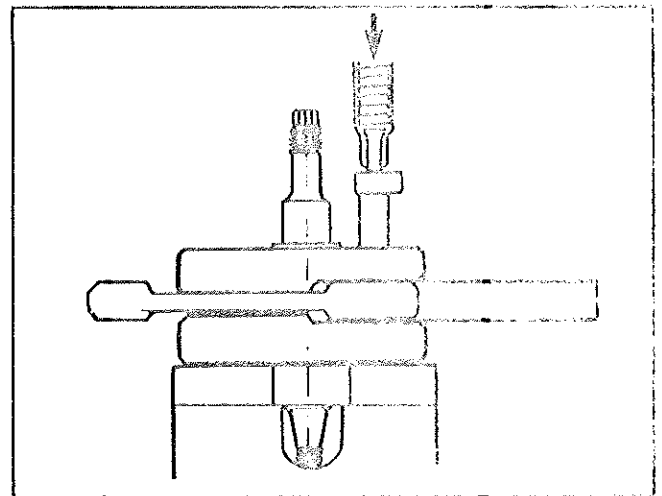
1. Mount the crankshaft assembly in a jig and press the crankpin out of the magneto side flywheel.
2. Remove the connecting rod and the bearing.

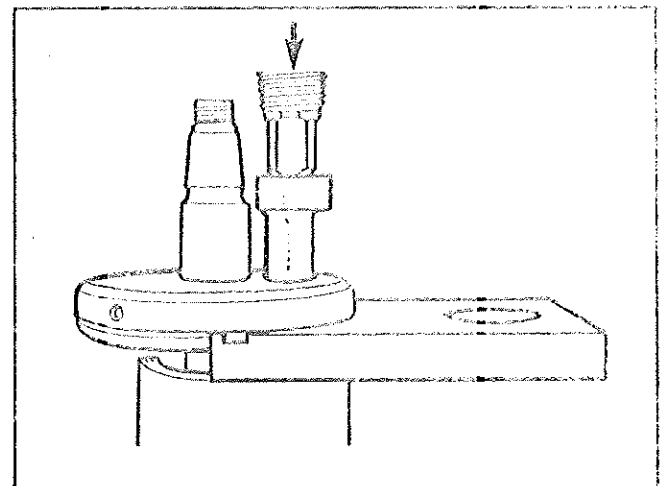
3. Press the crankpin out of the clutch side flywheel.

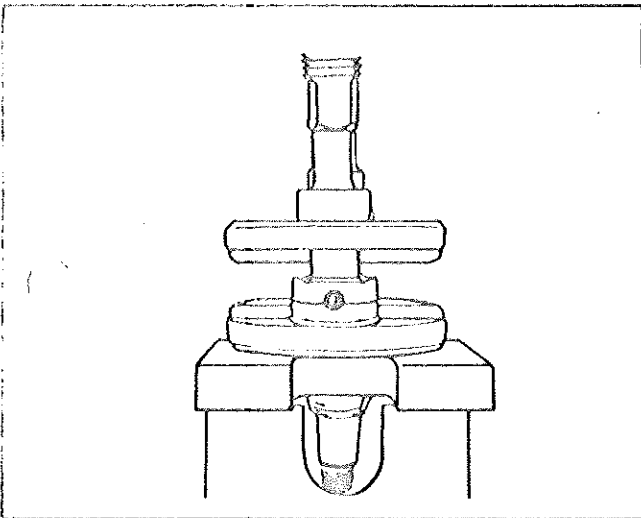
4. Press the new crankpin into the clutch side flywheel. Crankpin lubrication hole must point to the outside.

NOTE: The crankpin must enter the bore straight to prevent damage to the bore and/or the crankpin.

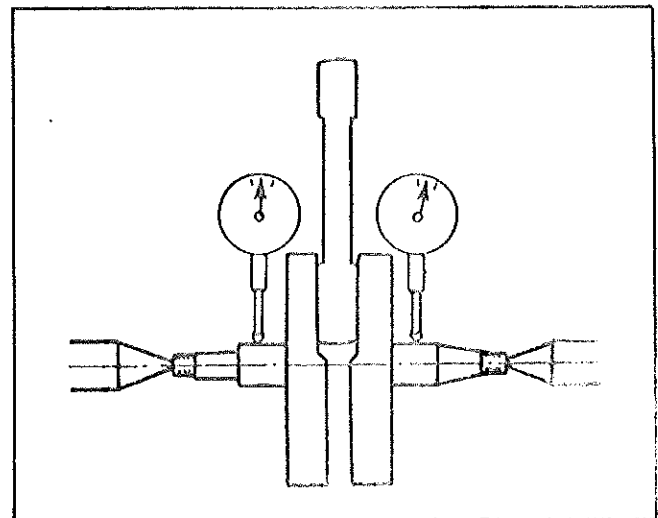
9. When overall alignment is completed, verify connecting rod side clearance.

NOTE: Make a final alignment check using a dial indicator.

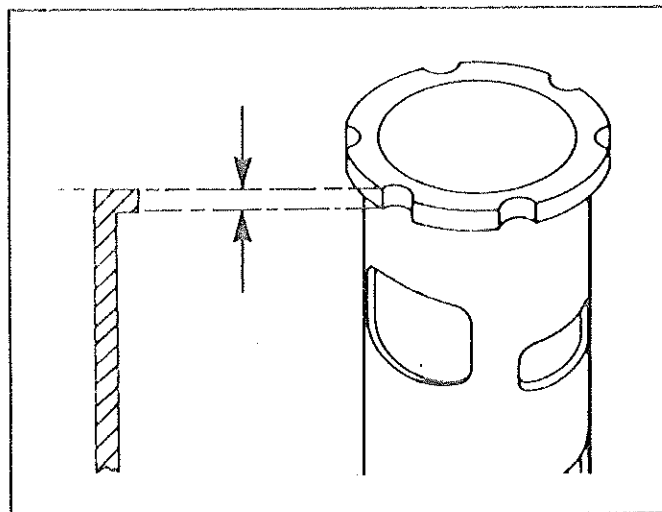
3) Measure the thickness of the liner top flange, and if necessary, face the new liner flange to the same measurement.

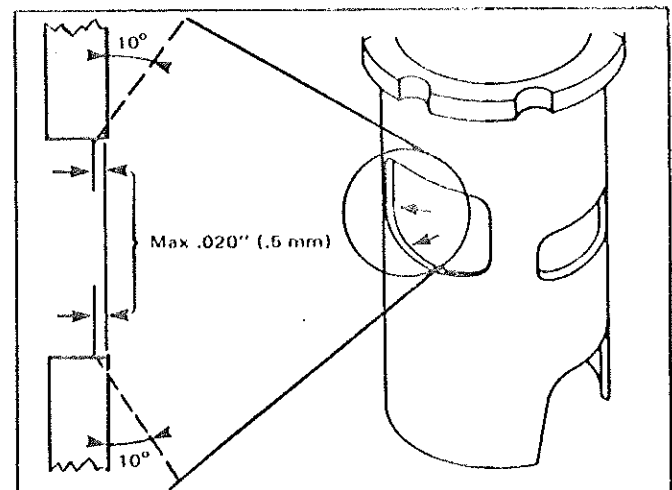
8) Using a rotary file or jeweler's hand file, chamfer the sharp edges of each port 10°, to a width of .020" (.5 mm).

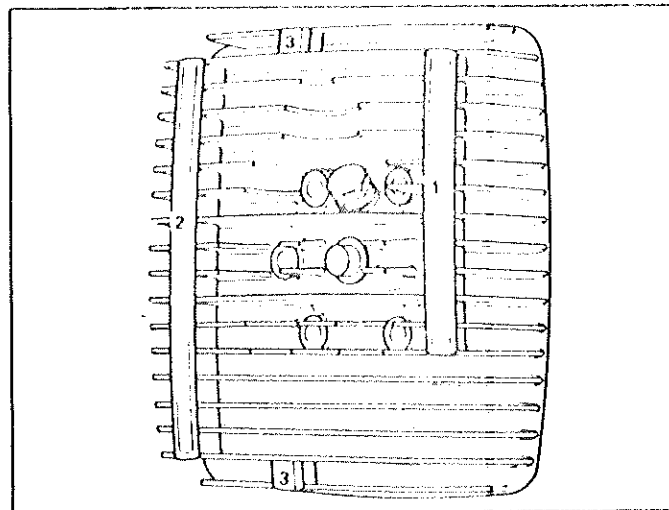
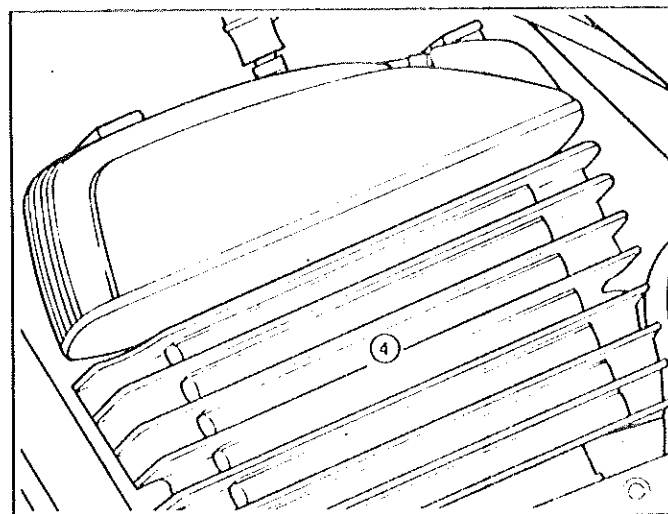
In order to lower the sound level of the engine power head, the '74 T'NT's noise dampers can be fitted to all other Can-Am motorcycle engines.

- ① Damper No 734-011-000 (short) fit rear of cylinder head. 1 -
- ② Damper No 734-011-001 (long) fit front of cylinder head. 1 -
- ③ Damper No 734-011-002 (small) fit both sides of cylinder head. 2 -
- ④ Damper No 734-011-003 should be inserted between cylinder fins. 12 -

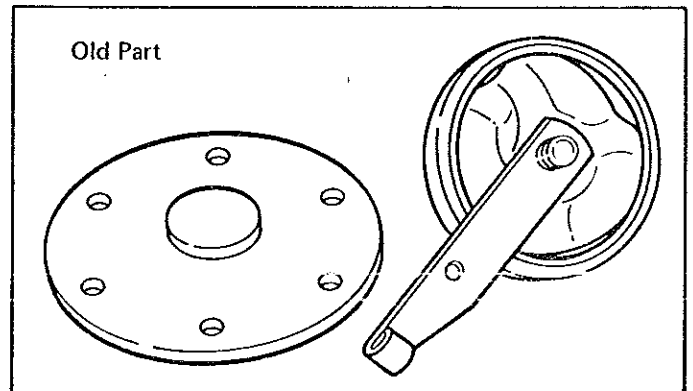
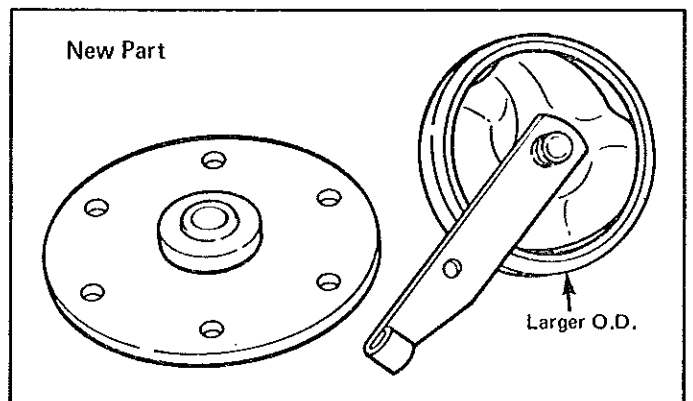
Clutch drag, due to plate warpage, is normally the result of excessive clutch slippage and bad driving habits.

In order to correct slight clutch drag, a new clutch release cam assembly has been designed and is standard on all 74 T'NT 175cc.

NOTE: On 125cc T'NT 74 only, if the steel plates are warped excessively, align the plates so that the warped part on each plate faces the same way and is in the same position.

Part name	Old part no.	New part no.
Plate, clutch spring retaining	420-259-590	420-259-596
Clutch release cam	420-259-615	420-259-619
Clutch adjustment screw	420-241-790	420-241-791
Clutch release bearing	420-932-990	
	420-259-600	420-259-705

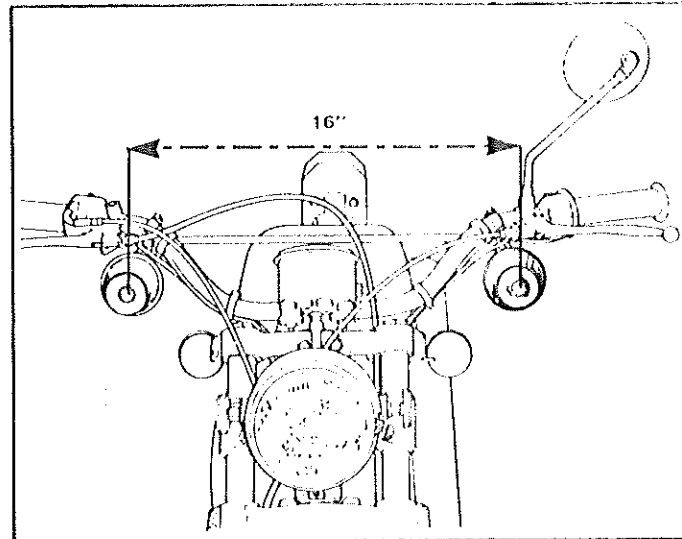
On pre-delivery or whenever a Cam-Am motorcycle is serviced, make sure the front turn signal lamps are positioned 16" apart. (Center to center). This a legal requirement and it has to be adhered to.

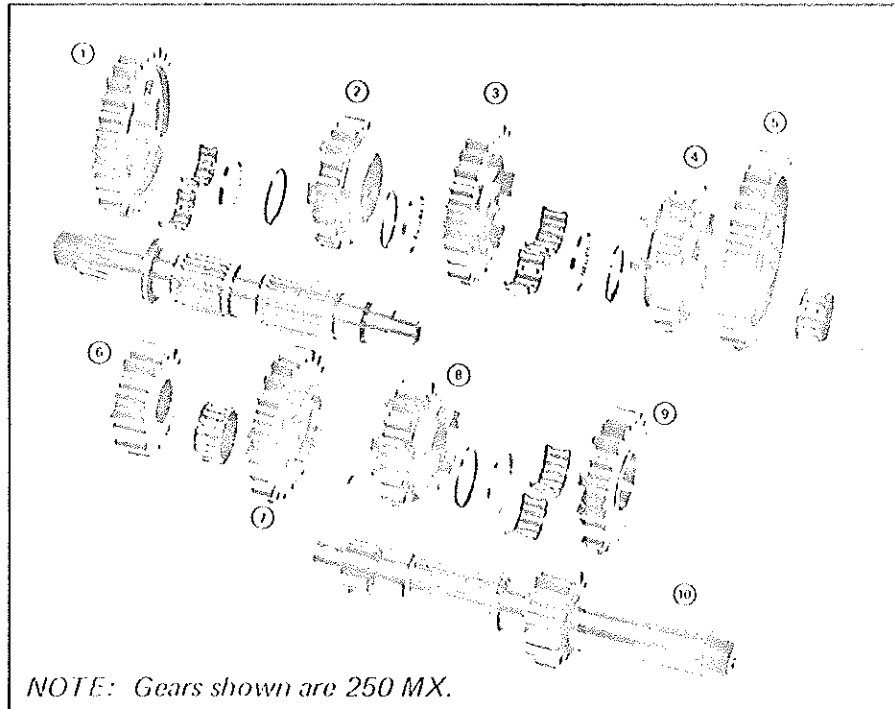
The Can-Am 5-speed gearbox can be rebuilt as per the instructions found in the current shop manual. The picture below indicates the correct location of each gear.
